ON TAP

Volume 17 Issue 2

2010 WINTER RAINS AFTERMATH

Trabuco Canyon Water District

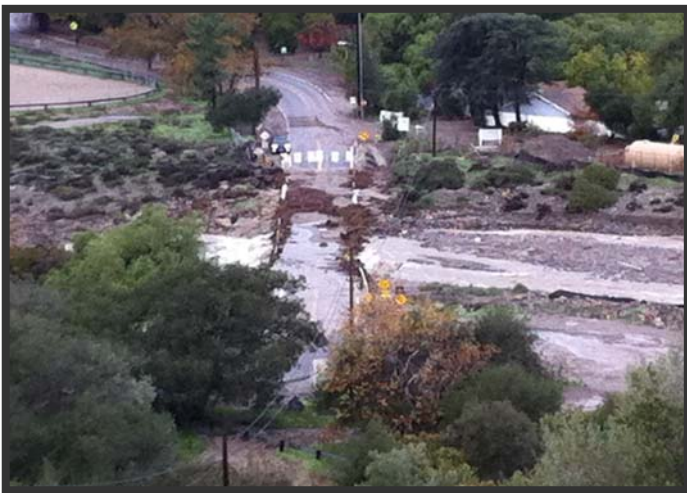
The first picture is a familiar sight to many District customers. When serious rainstorms sweep through the Canyon, the bridge at Trabuco Creek Road can experience heavy flooding.

As evident in this picture, flooding can be to the point of the creek overtaking this main Canyon entry point. This situation presents a serious problem for both local residents and first responders, as it limits access to the Canyon. One of TCWD's concerns at this

location was the preservation of the Rose and Lang Wells Treatment Facility, which is in the final stages of a multi-million dollar upgrade project. Although the rushing waters from the creek eroded a large amount of soil, the first responders worked quickly to protect the well facility and transmission pipelines.

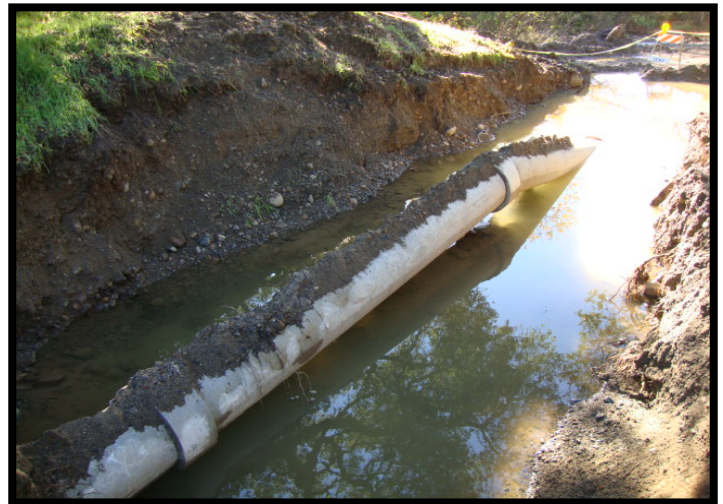
One of TCWD's primary potable water transmission lines was severely impacted by the storm.

In this picture, a sixteen-inch pipeline was exposed when the creek jumped its natural creek-bed and eroded nearly six feet of soil. When the soil was washed away, the high water pressure in the line forced the pipe to deflect and rupture, which resulted in the unnatural angle in the pipe shown in the photo. TCWD Water Department employees responded to this line break early in the morning before dawn, braving the elements and harsh storm conditions to ensure local residents in this remote location had water access.

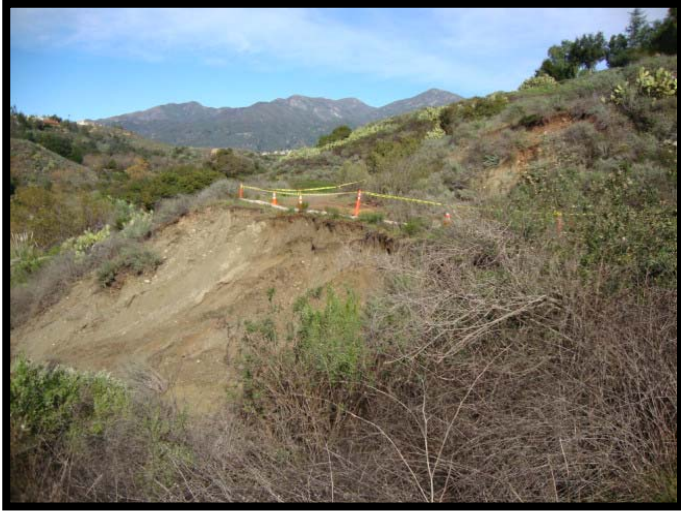
The following image demonstrates one of the slides of soil on the access road that borders Dove Lake.

This road is used frequently by both TCWD staff and local trail enthusiasts on weekend hikes. Two major pipelines lie in the service road and the slide placed these lines in jeopardy. Although this represents the largest slope failure on the access road, there were also a number of smaller ones along the road on both sides. The damage to the area forced the closure of the road and resulted in a large amount of debris removal once the road surface dried enough to allow it.

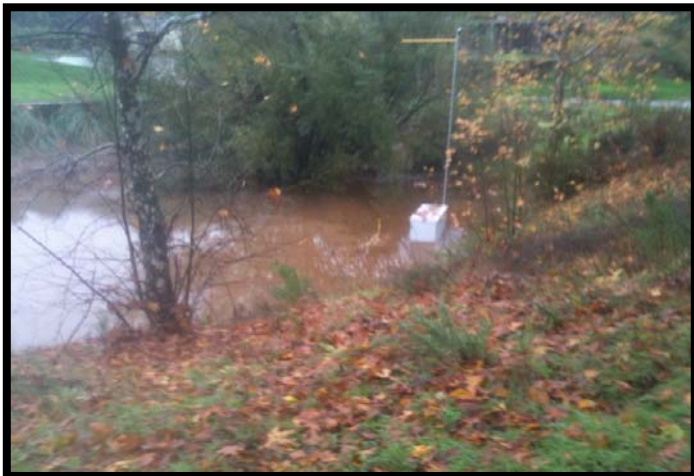
Finally, in order to truly grasp the impact of over five inches of constant rainfall over a twelve hour period, a glimpse of TCWD's Tick Creek Pump Station submerged under six feet of water is a sight to be seen.

This facility is one of the District's Dry Season Recovery Pump Stations in Dove Canyon. Unfortunately, it is at a low point in the system and

suffered as a result. The saving grace in this instance is that the pumps at this location are submersible by design. The greatest impact to this facility was the failure of the electrical components due to the flooding. The structure seen in this picture is approximately eight feet high.
